Physics of Reactors Topical Meeting 2014 - PHYSOR2014

Current Status on Fukushima Daiichi NPS

September 29, 2014

Tokyo Electric Power Company

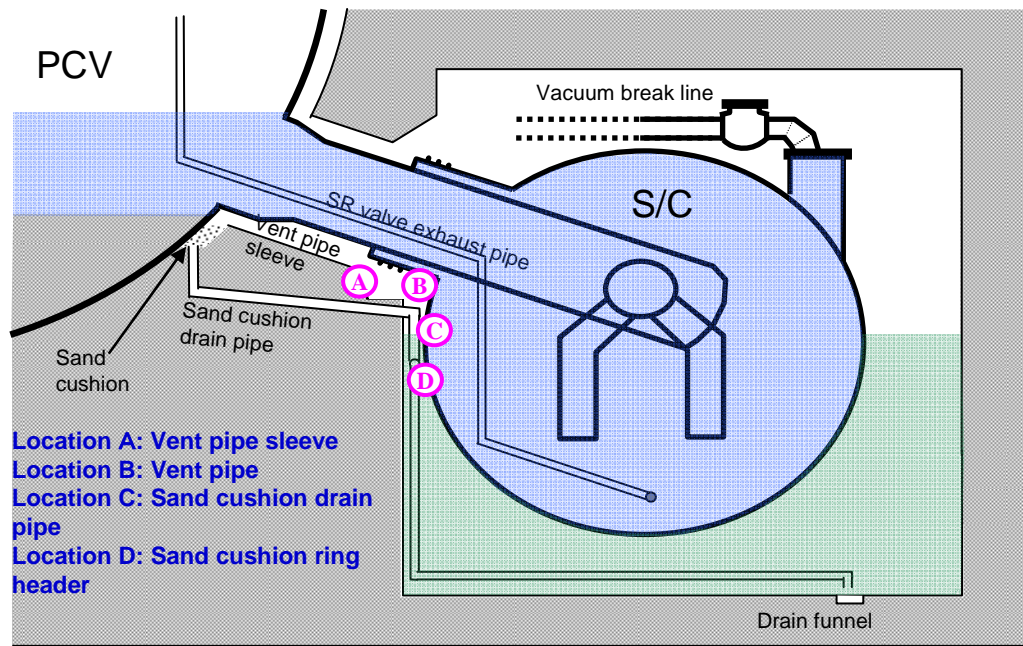
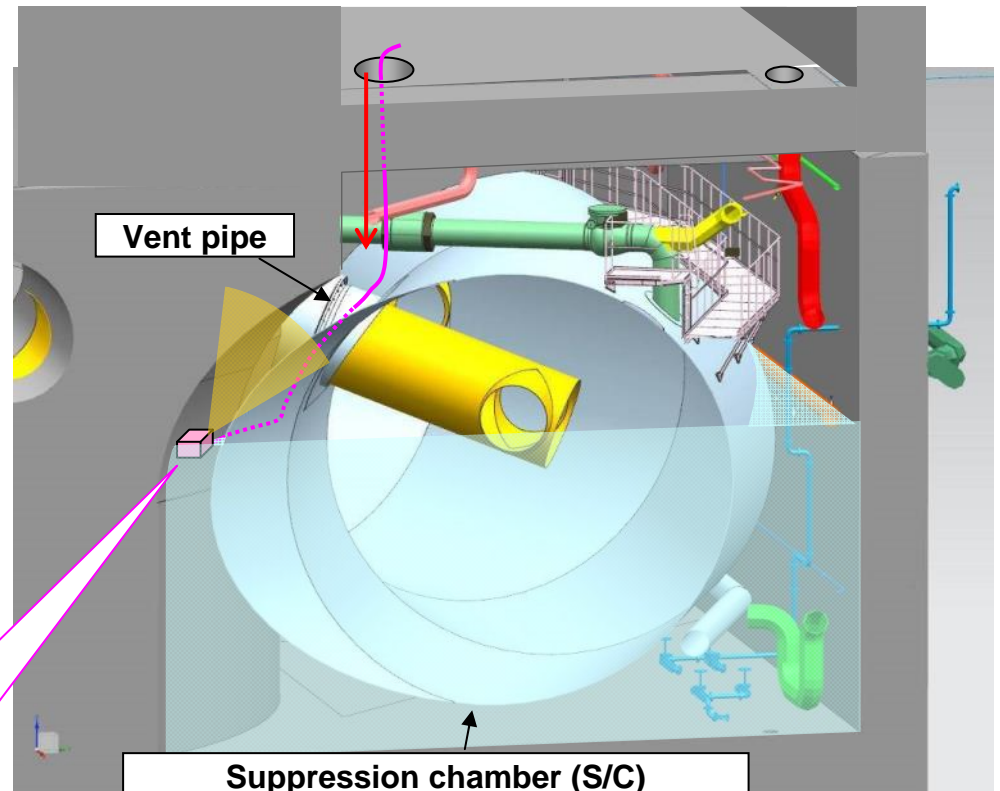
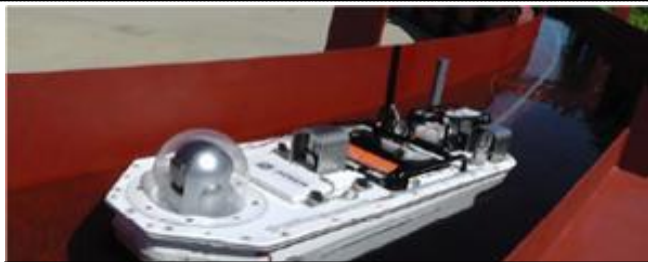
- To repair (seal the water leak locations of) the PCV in preparation for the fuel debris removal, investigation under vent pipes was conducted to identify the leak locations in the PCV.
- With the images taken by the camera equipped with the water boat, it was checked whether there is any water flow from the sleeve ends of vent pipes or not, and the status of the sand cushion drain pipes was also checked (by viewing appearance).

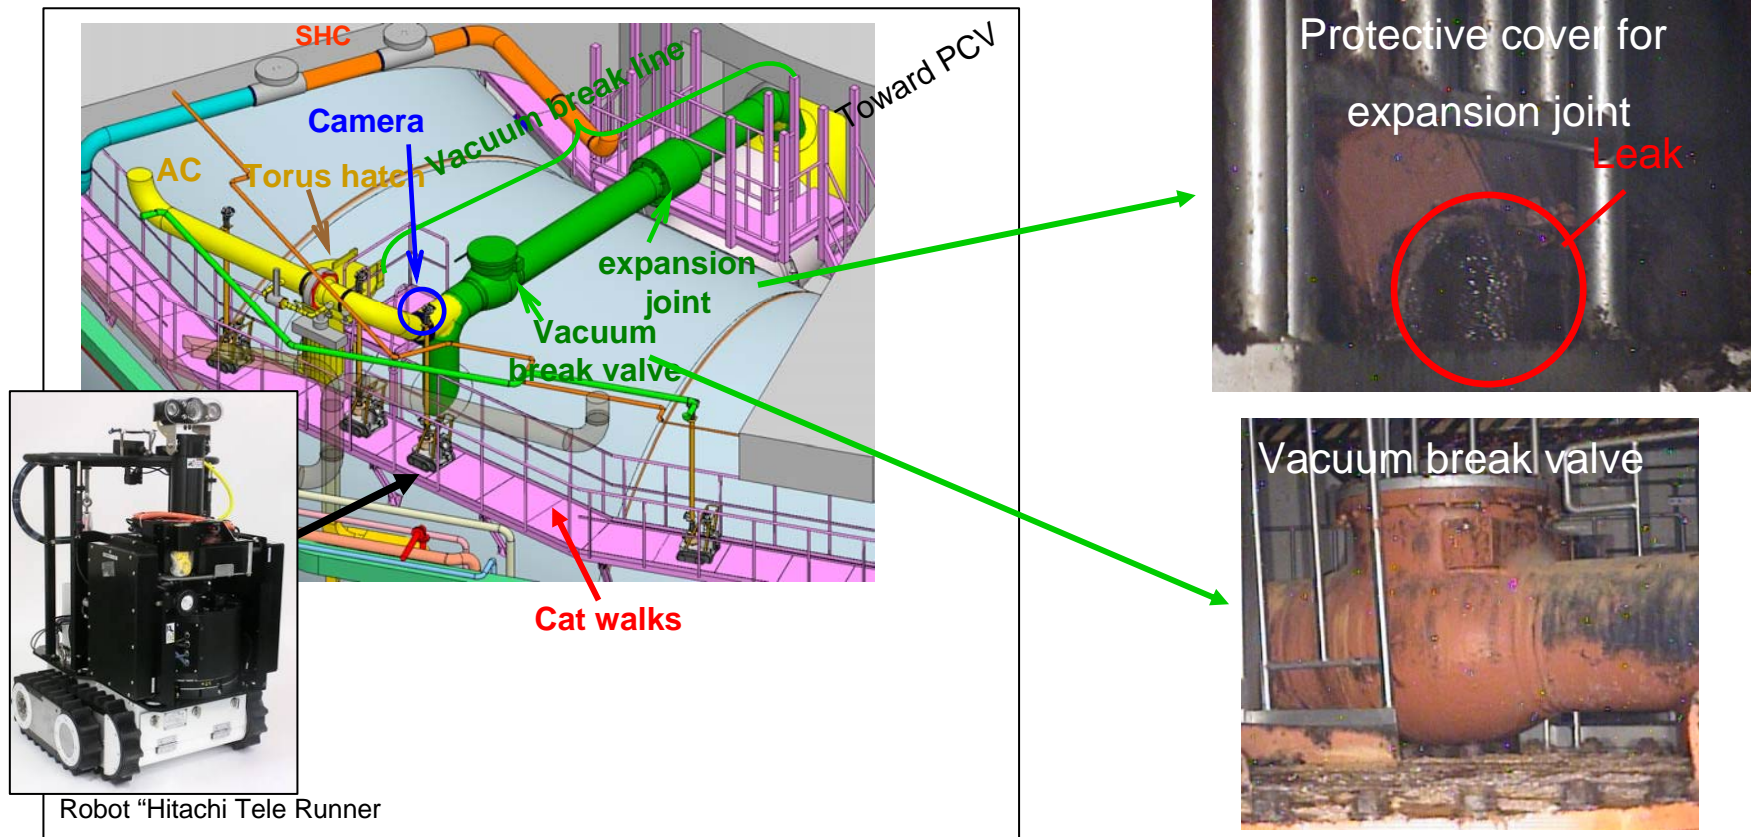
Image of investigation on upper part of suppression chamber

- By deploying a remote controlled robot on the cat walks in the torus room in the unit 1 from May 27, a leak from the cover of a expansion joint on vacuum break line was identified.
- The investigation results will be reflected into the planning for further investigation and sealing the PCV for filling the PCV with water in the future.

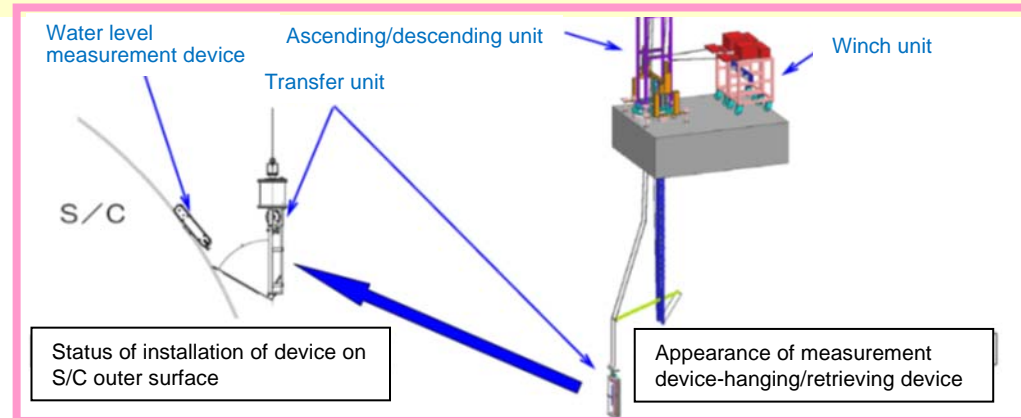
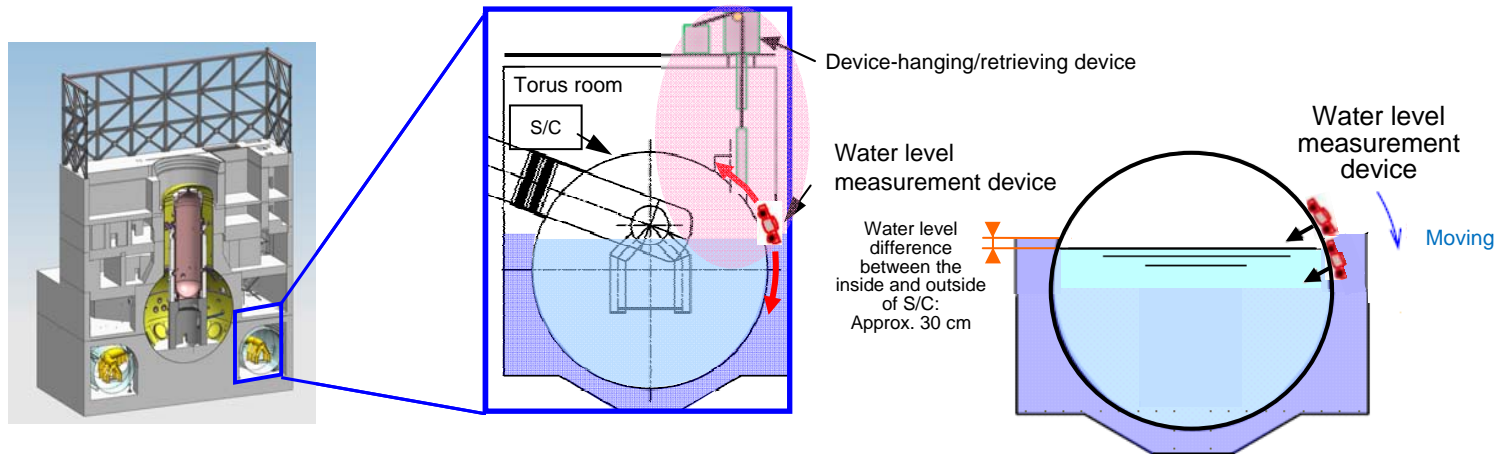
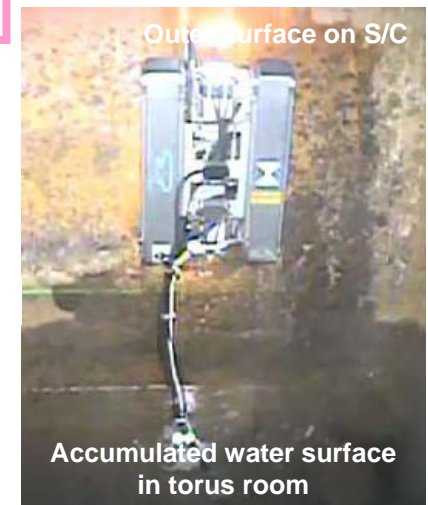
Overview on water level measurement in S/C at Unit 2

- To repair (seal the water leak locations of) the PCV in preparation for the fuel debris removal, the water level in S/C was measured to assume the state of the opening area at leak locations in the PCV. (By checking the water level difference between the inside and outside of the S/C, the opening area was assumed, and it will be considered that it is possible whether the water sealing material might flow out of the S/C or not.)

- The measuring was conducted from January 14 to 16 at multiple lines (multiple longitudes) in order to enhance the reliability of specifying the exact water level. The numerical values of January 14 and 15 in the following chart were obtained in the middle of the series of the data collecting work.

[Note] It is estimated that the water level inside the S/C is influenced by the change of the water level of accumulating water inside the torus room.

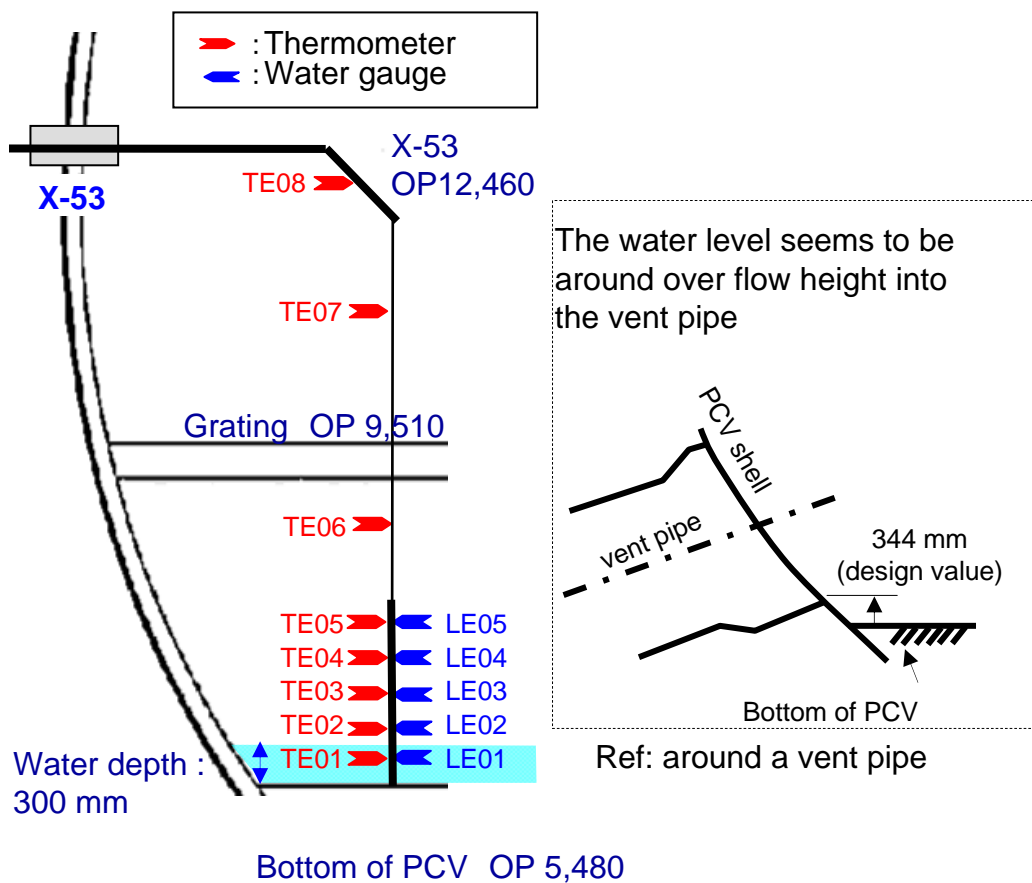
Measurement of water levels inside of PCV in Unit 2

- After failing to insert a measurement instrument in March 2012, re-inserting of an instrument was successful in early June 2014.
- Water levels and temperatures inside PCV have since been monitored.

Monitoring results				Height
	Temp.[°C]	Water level		
TE08	33.7	-	-	OP.11,920
TE07	33.7	-	-	OP.10,690
TE06	33.5	-	-	OP.8,100
TE05	33.5	LE05	OFF	OP.6,430
TE04	33.5	LE04	OFF	OP.6,230
TE03	33.6	LE03	OFF	OP.6,030
TE02	35.0	LE02	OFF	OP.5,830 *350 mm from the bottom of PCV
TE01	35.8	LE01	ON	OP.5,630 * 350 mm from the bottom of PCV

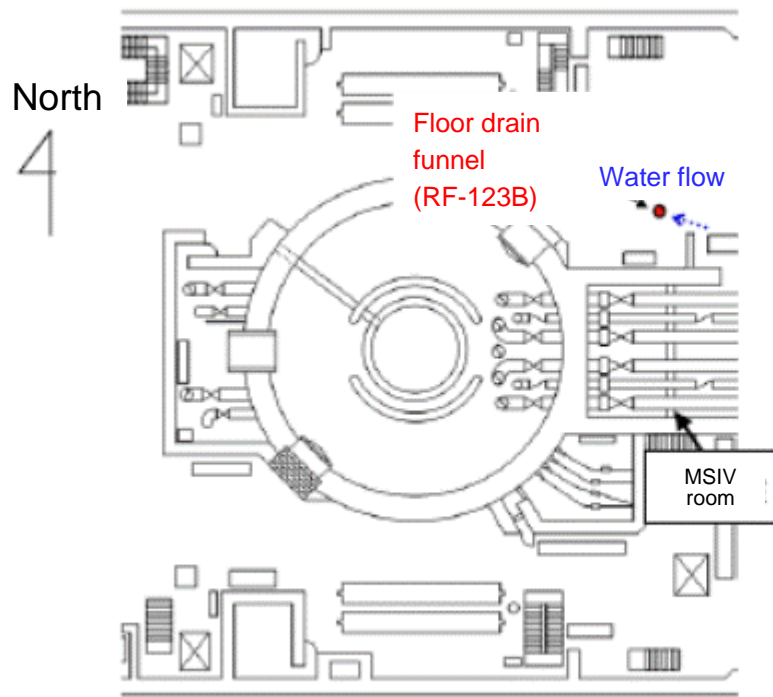
Floor map of 1st floor in R/B at Unit 3

Water flow from area near MSIV room to floor drain funnel on 1st floor in R/B at Unit 3

- On January 18, 2014, checking the camera images from the debris removal robot (ASTACO-SoRa) in unit 3, our personnel found that water flowing from the area near the door of the main steam isolation valve (MSIV) room toward the floor drain funnel in the vicinity in the north-eastern area on the 1st floor at Unit 3 R/B.
- On January 21, 2014, it was identified that water injection amount was greatly reduced while the robot was operated for debris removal work.
- No change on plant parameter, etc has been found.

Water flow confirmed (on Jan. 18)

Water flow reduction confirmed (on Jan. 21)

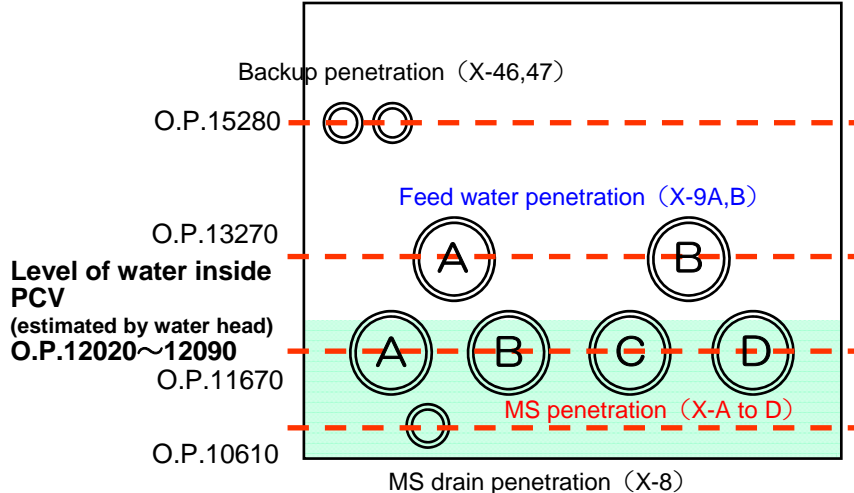
Penetration on PCV in MSIV room

- On May 15, by inserting a camera into the Main Steam Isolation Valve (MSIV) room, a leak from around a Main Steam (MS) line was identified. It was the first confirmation of a leak from the Unit 3 PCV.

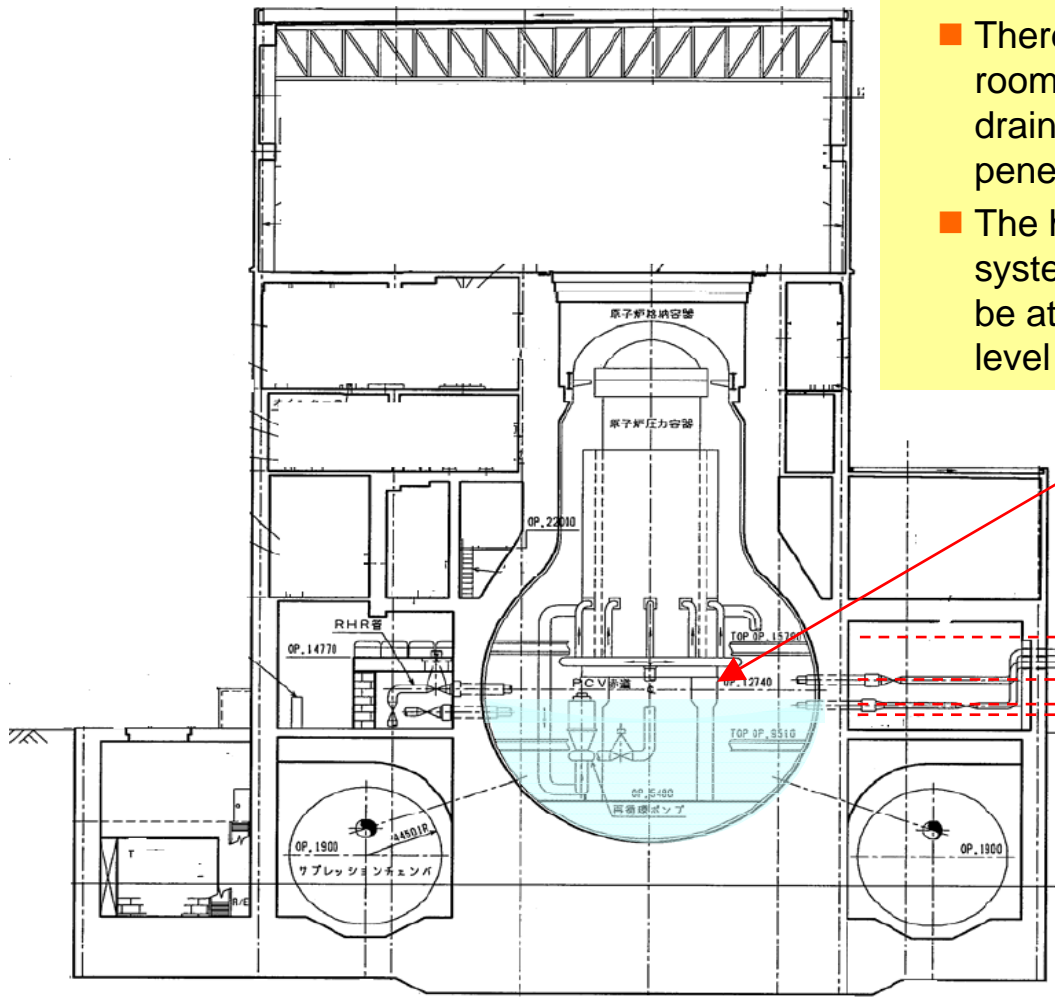
Unit 3 Reactor Building cross-section

- There are a total of 9 pipe penetration seals in the MSIV room: main steam system (X-7A~D), main steam system drain (X-8), feed water system (X-9A,B), and the backup penetrations (X-46,47)
- The height of the main steam system and the main steam system drain penetrations (total of 5 places) are estimated to be at a lower level than PCV water level (estimated water level from pressure conversion)

Containment vessel water level
(Estimated water level from pressure conversion)
O.P.12020~12090

Backup(X-46,47)
Height: O.P. approx. 14800~15300

Feed water system pipe penetration seal (X-9A,B)
Height: O.P. approx. 12800~13700

Main steam system pipe penetration seal (X-7A~D)
Height: O.P. approx. 11100~12200

Main steam system drain pipe penetration seal (X-8)
Height: O.P. approx. 10400~10800
