TEPCO's Activities on the Investigation of Fukushima Daiichi Accident

2014/09/28

Tokyo Electric Power Company

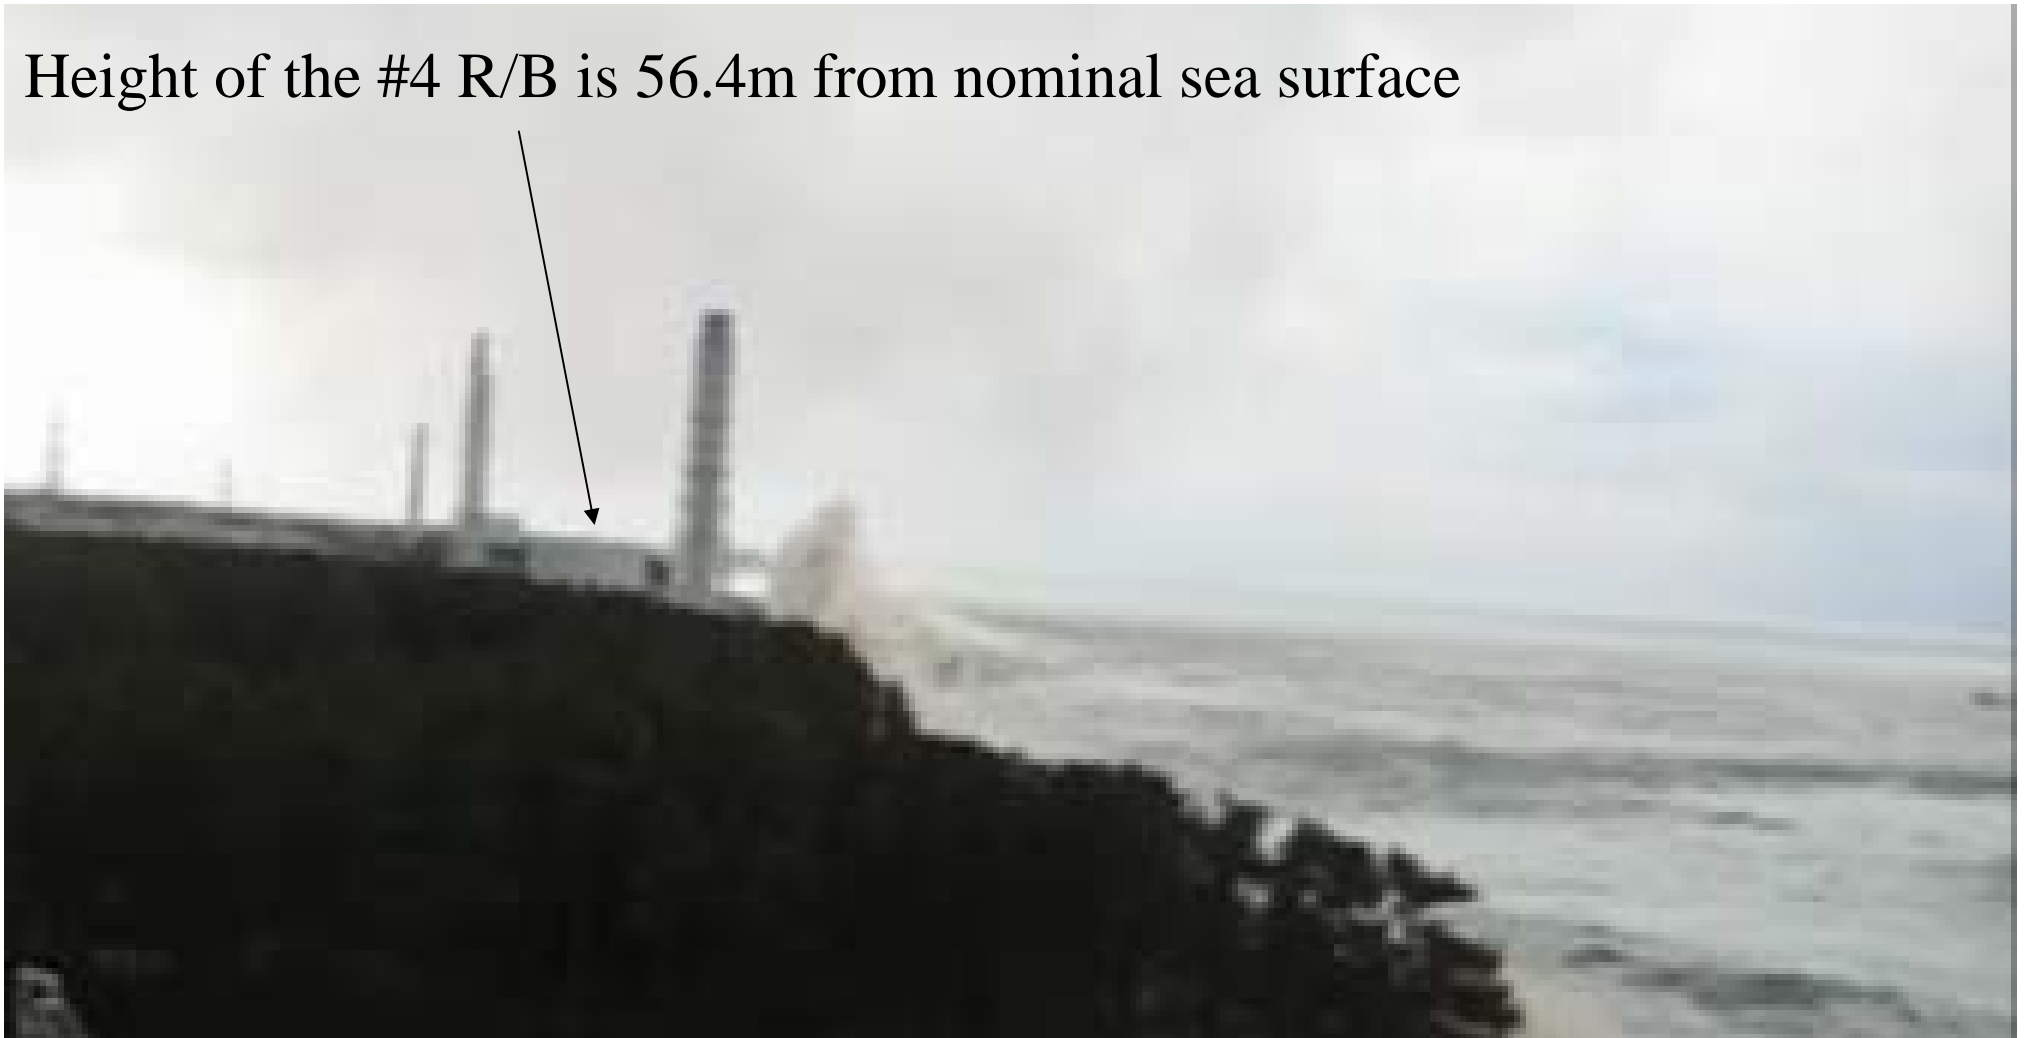
1. Tsunami attack to the Fukushima Daiichi NPS

Height of the #4 R/B is 56.4m from nominal sea surface

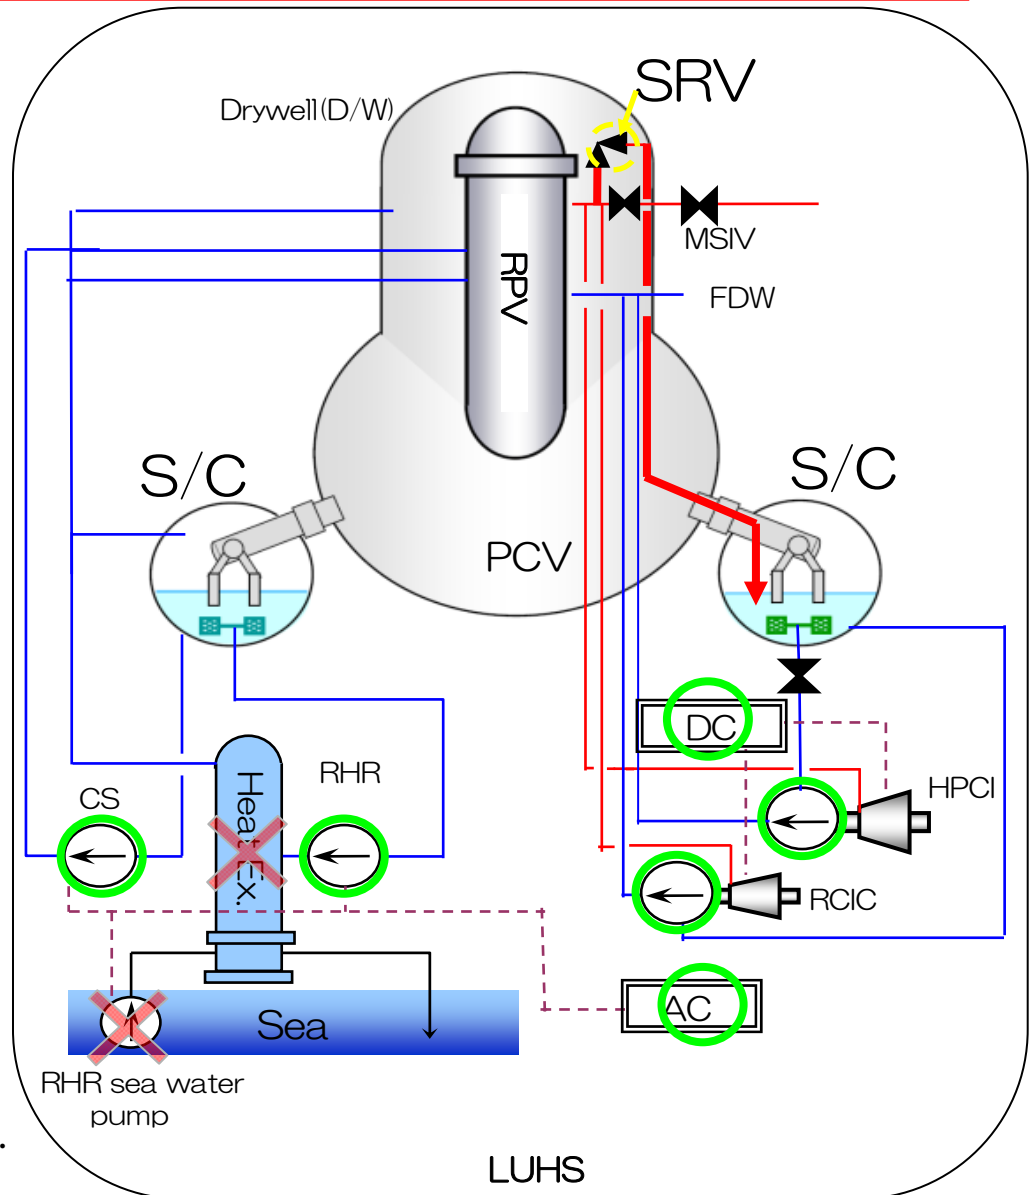
4. Loss of Ultimate Heat Sink : LUHS

- Decay heat removed from RPV will be transported to Suppression Chamber(S/C) through Safety Relief Valve(SRV).
 - Energy stored in the S/C will be released to the sea by means of heat exchanger in RHR (Residual Heat Removal system).
 - LUHS means the condition in which the decay heat could not be removed from S/C.
 - In case of LUHS, even if we could continue cooling the core, decay heat remains inside the PCV boundary.
- Temperature and pressure of the PCV increase gradually.

In unit 1, accident progression was so fast that we don't need to consider LUHS.
On the contrary, LUHS played an important role for the accident progression for unit 2/3.

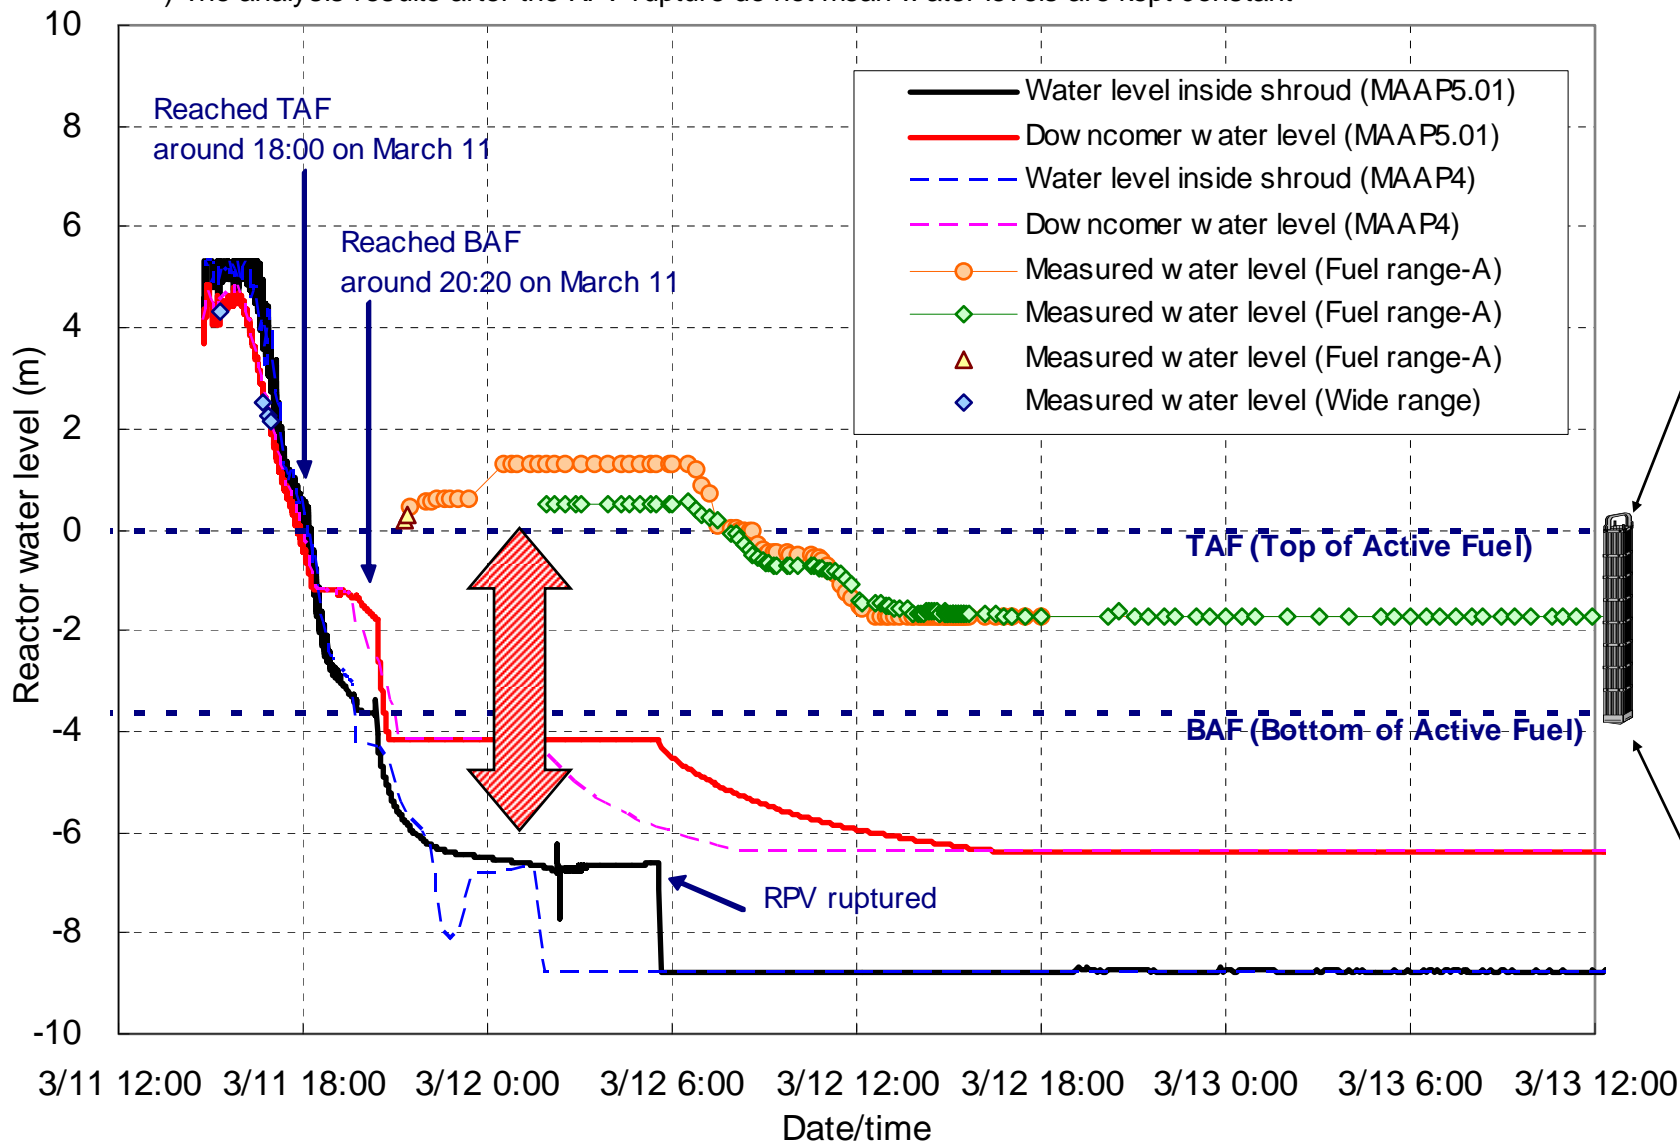
6. RPV water level in unit 1

*) The analysis results after the RPV rupture do not mean water levels are kept constant

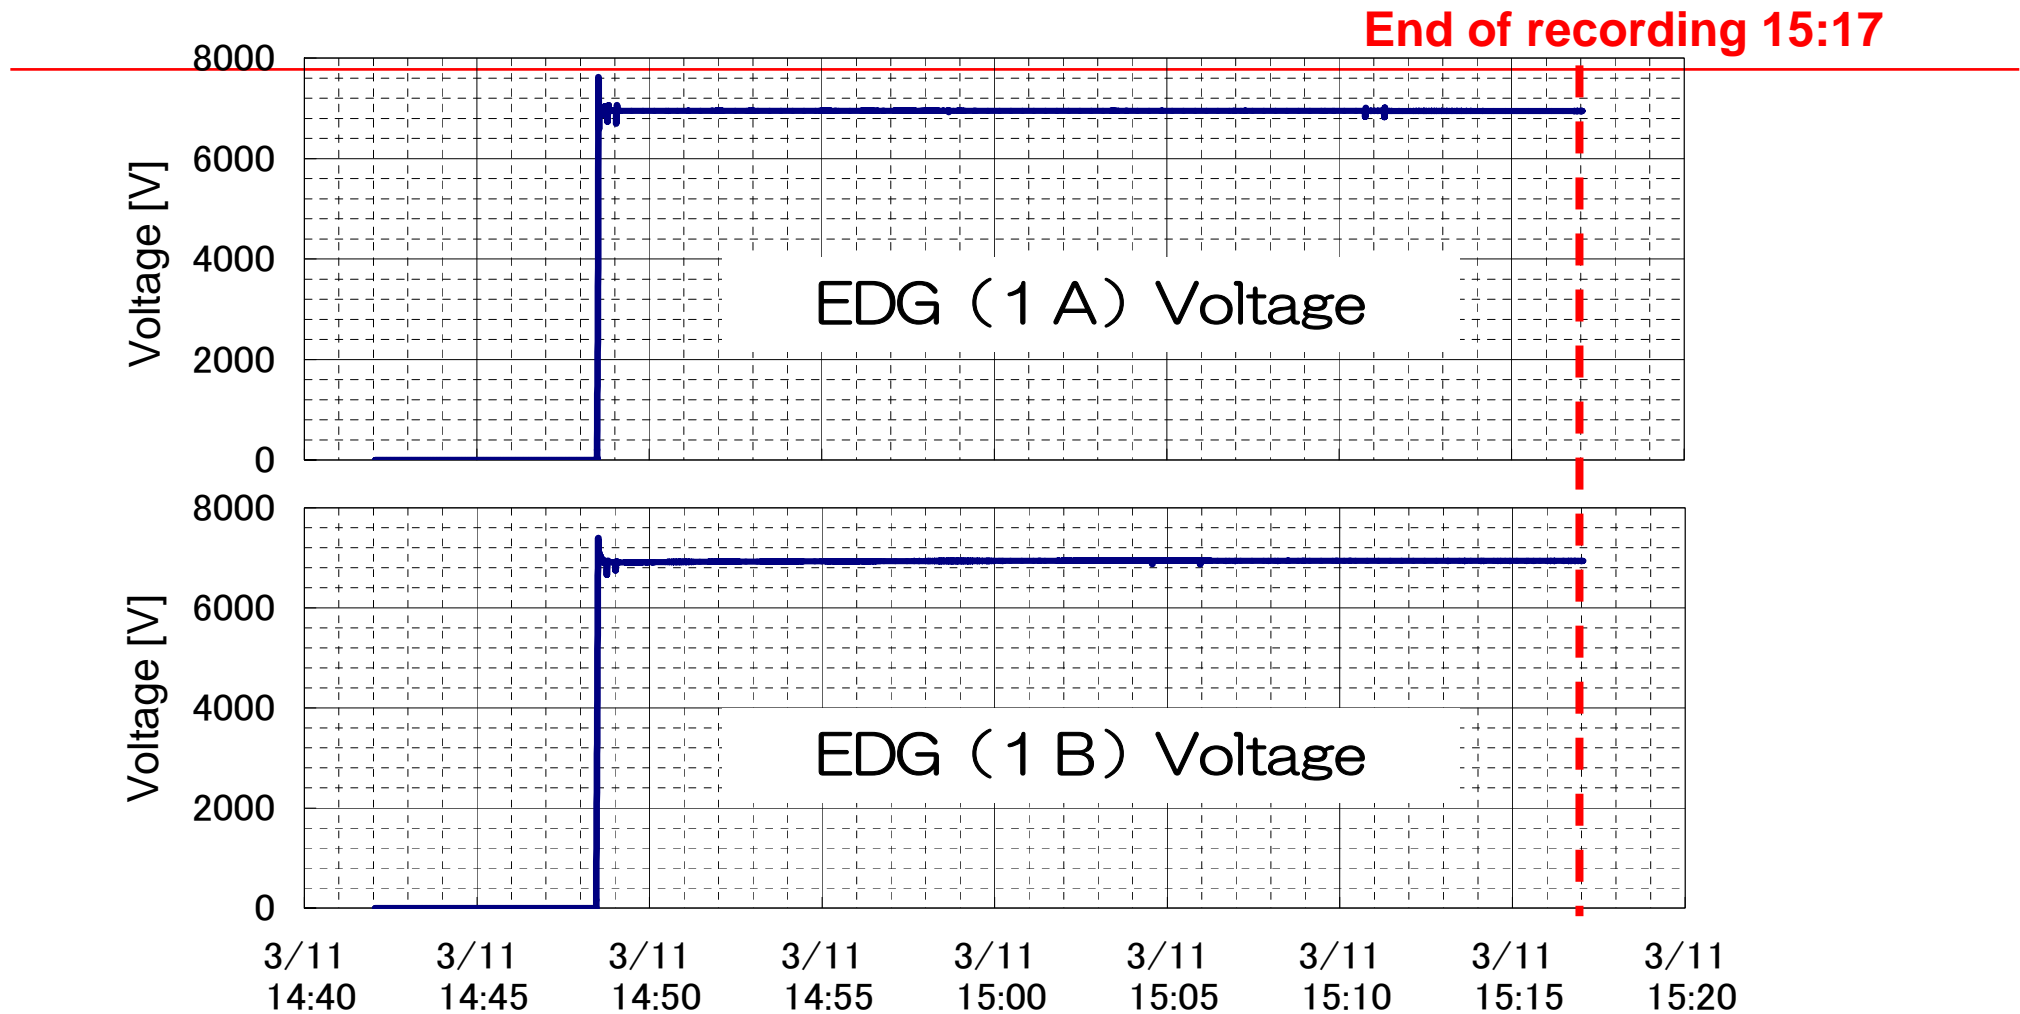
6. State of start up and operation of EDG (~15:17)

- The transient recorder recorded that EDG(A) (B) had operated normally until recording stop time. In addition, aftershocks with seismic intensity 4 occurred six times and with seismic intensity 3 occurred twice during the recording time.

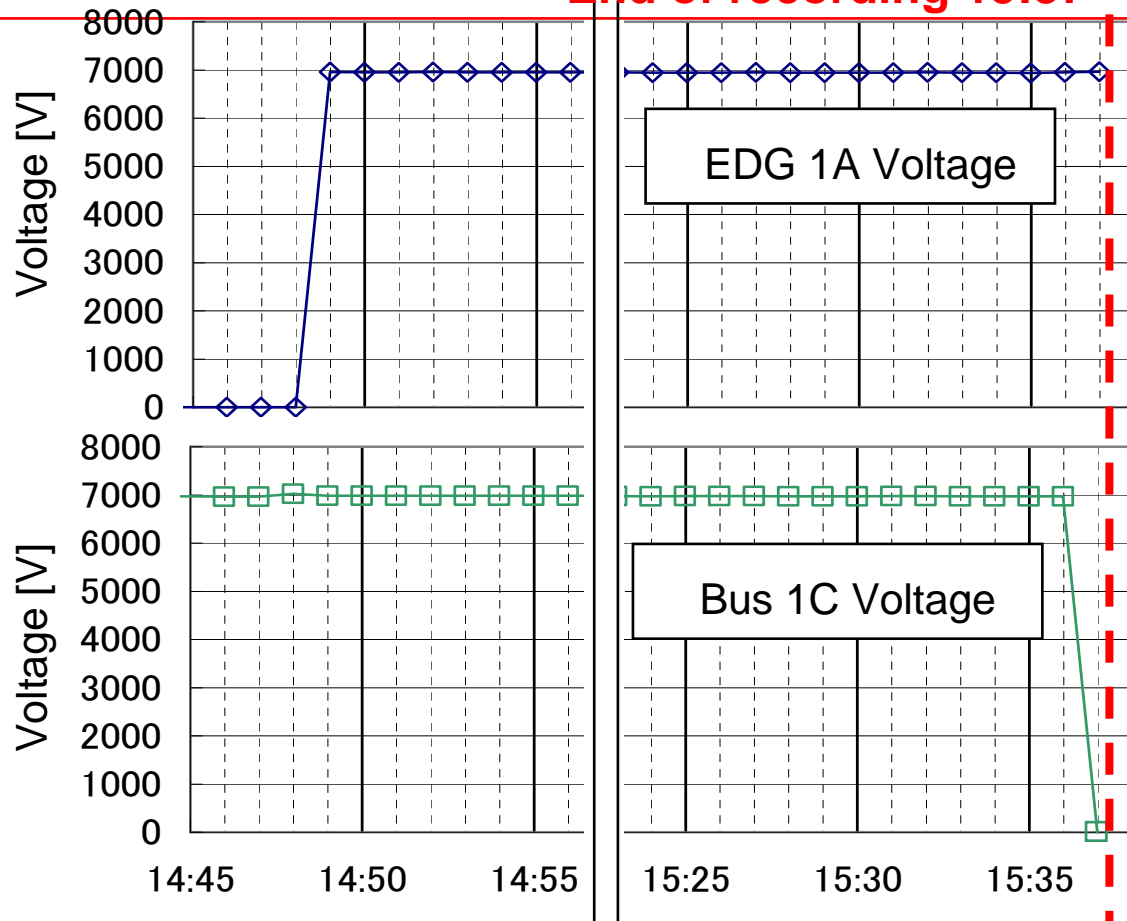
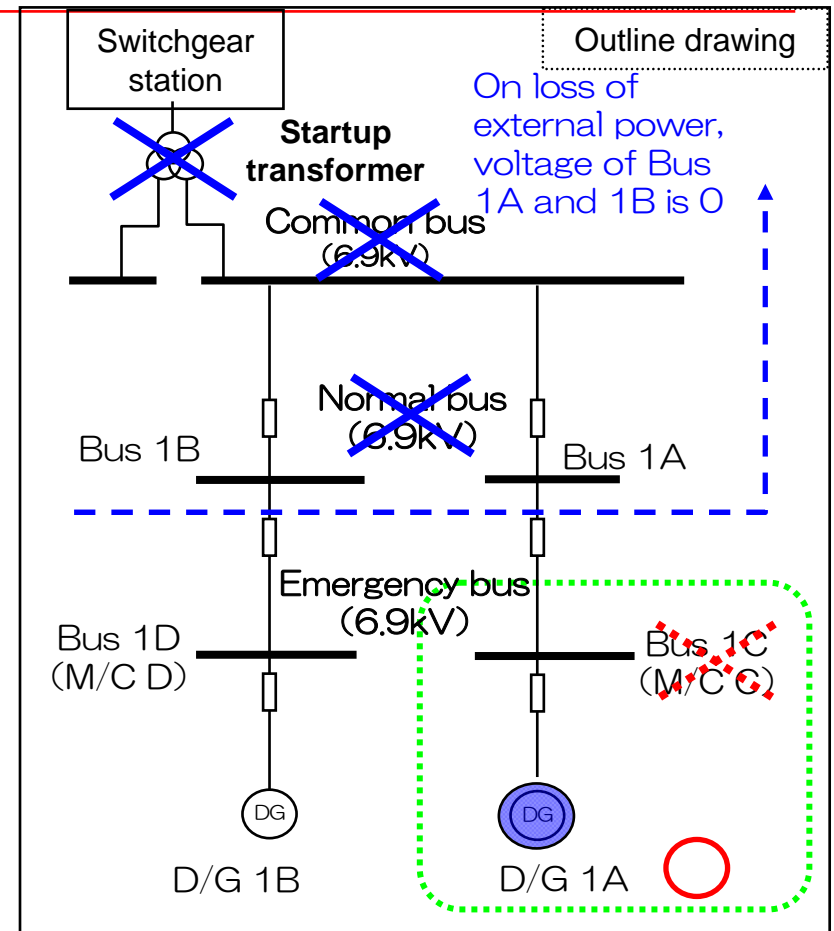
6. State of EDG operation (Time around Tsunami arrival)

End of recording 15:37

Data after 15:17 were recently confirmed

Voltage data at 15:37 shows EDG 1A at rated voltage, Bus 1C at 0 V
 → Bus 1C lost its function earlier than EDG 1A

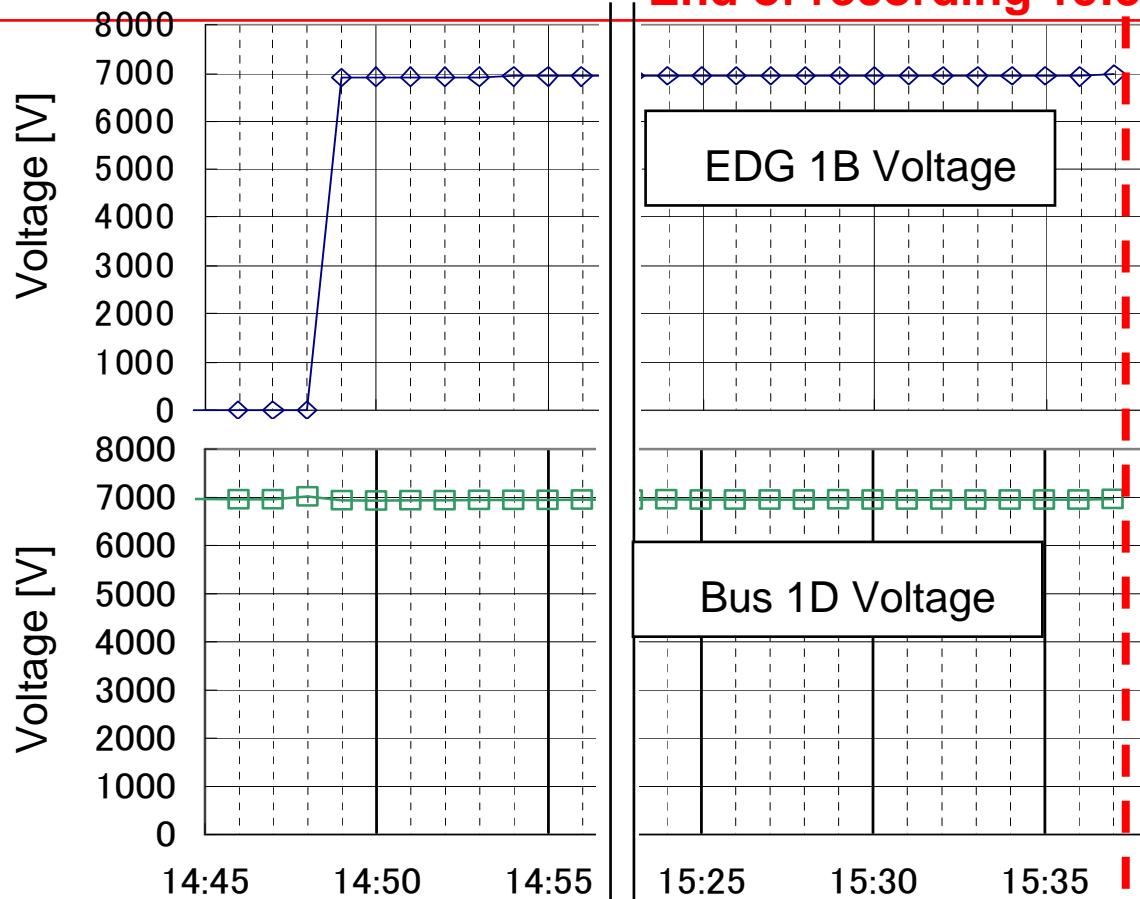
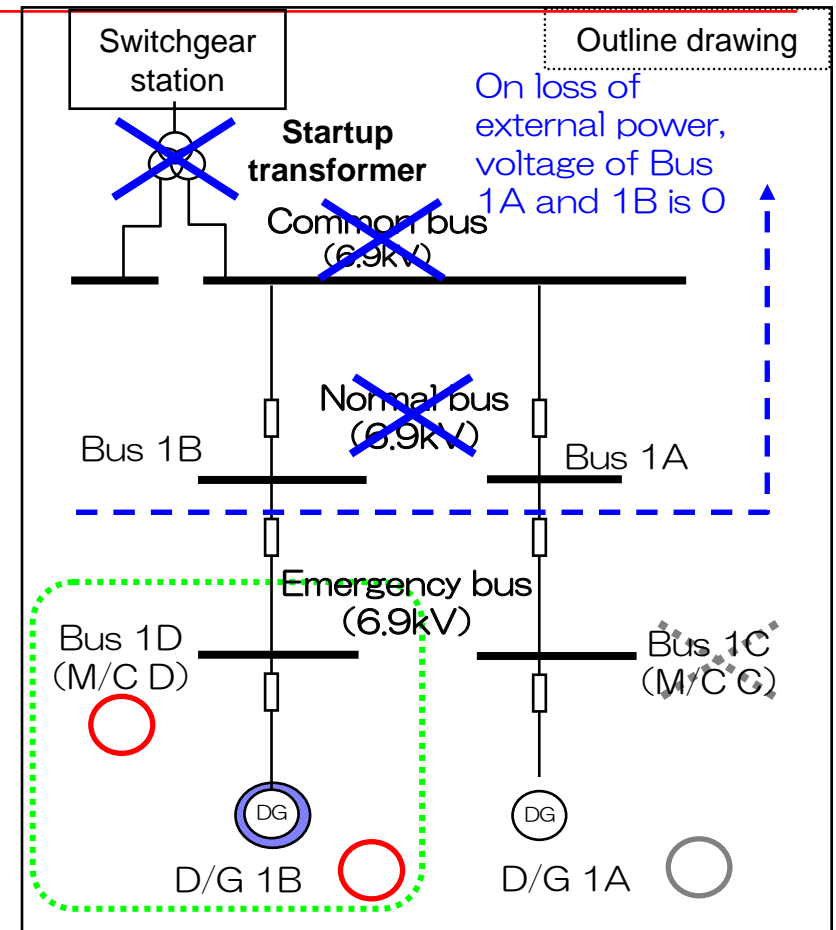
6. State of EDG operation (Time around Tsunami arrival)

End of recording 15:37

Data after 15:17 were recently confirmed

Voltage data at 15:37

Both EDG 1 B and Bus 1 D at rated voltage

→ It is not clear which lost function first, EDG or Bus.

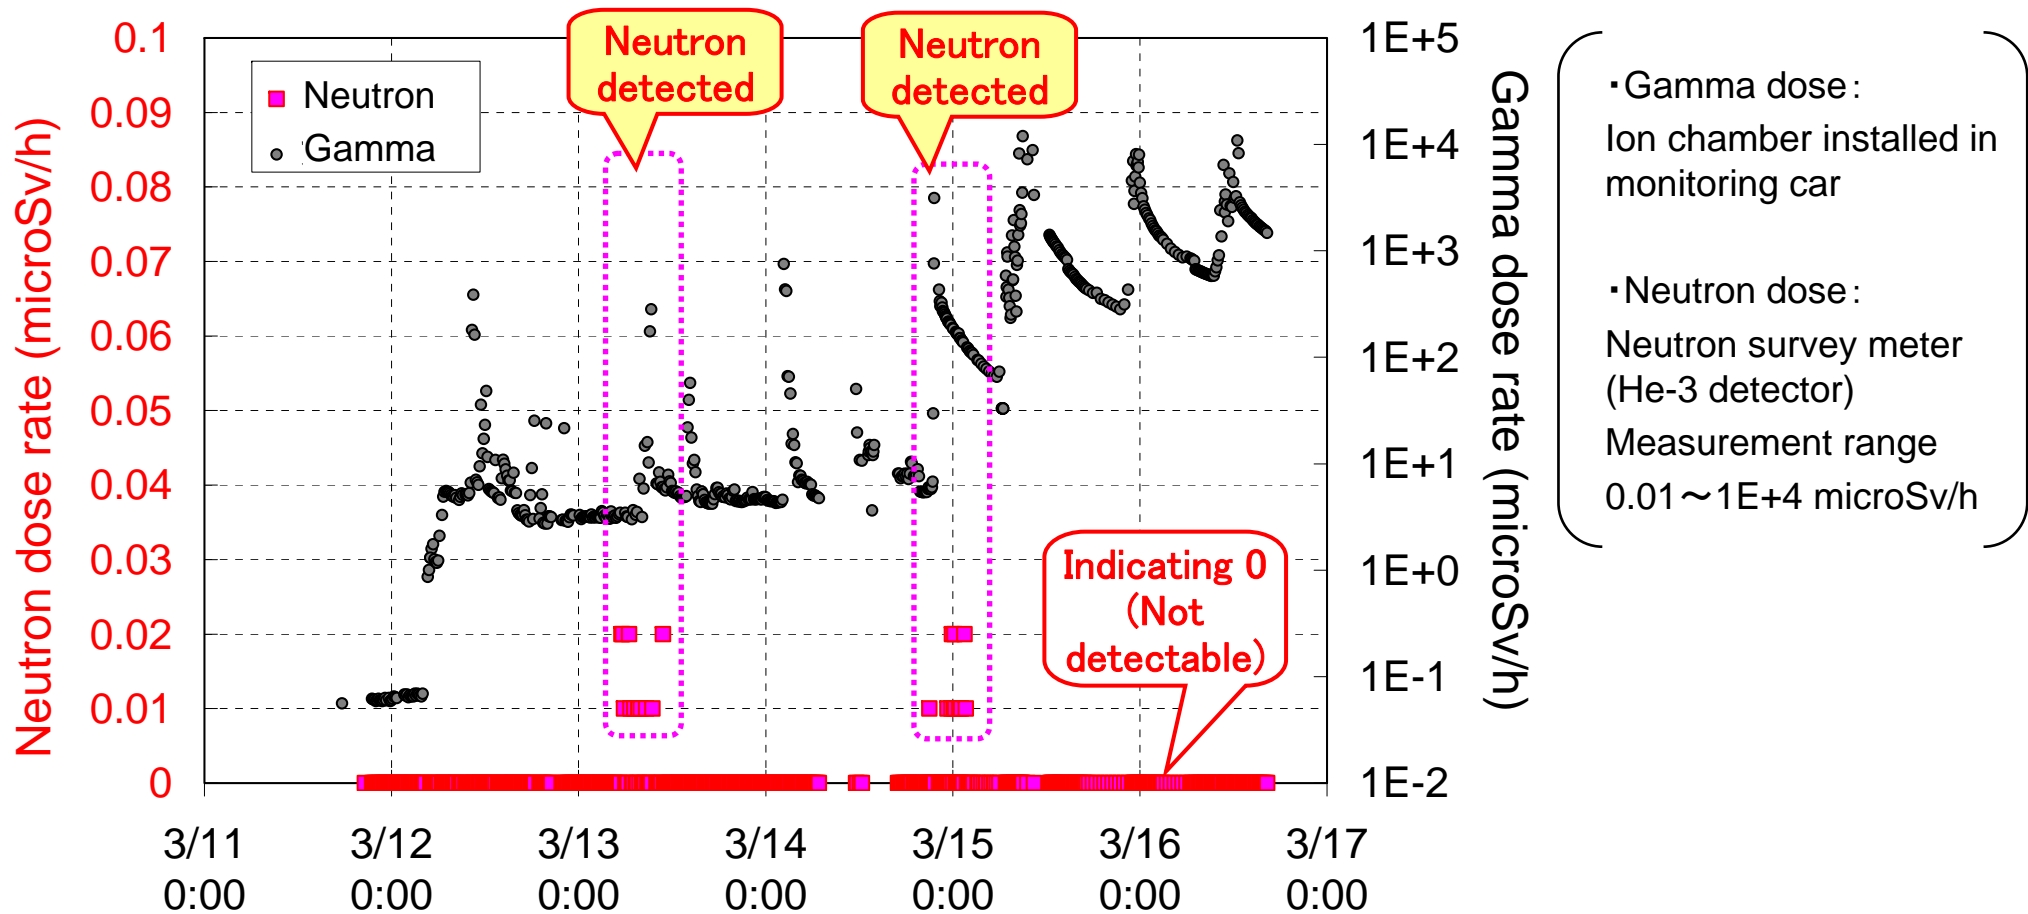
9. Neutron monitoring result (near main gate)

- We began the neutron monitoring from ca. 20:30 March 11. Neutrons were detected during the **two periods only**
- Measured value $0.02 \mu\text{Sv/h}$ (corresponding about 2cpm) is judged to be **not noise but actual neutron signal** from the survey meter spec. such as the gamma ray sensitivity and background signal level

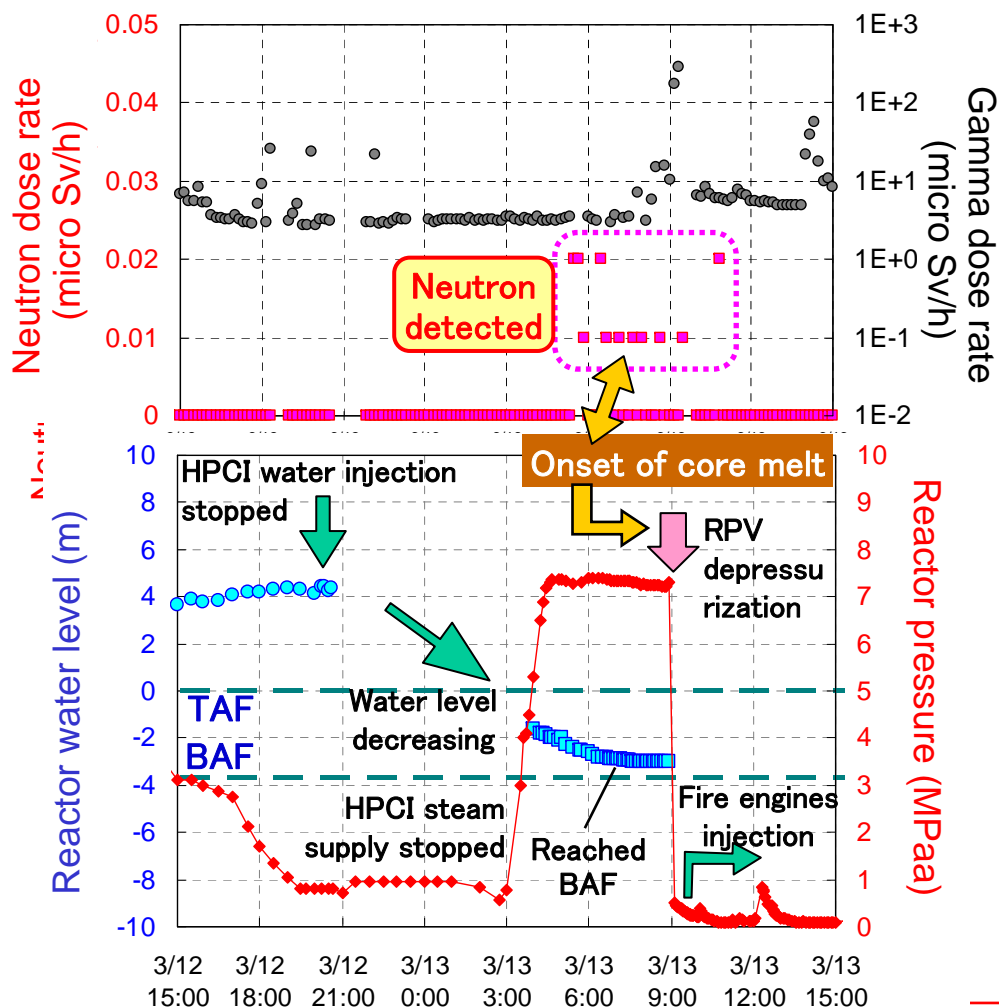
9. The timing to detect neutrons

First period to detect in the morning on March 13 coincides with the onset of core melt at Unit-3

Second period to detect in the midnight on March 14 coincides with the onset of core melt at Unit-2

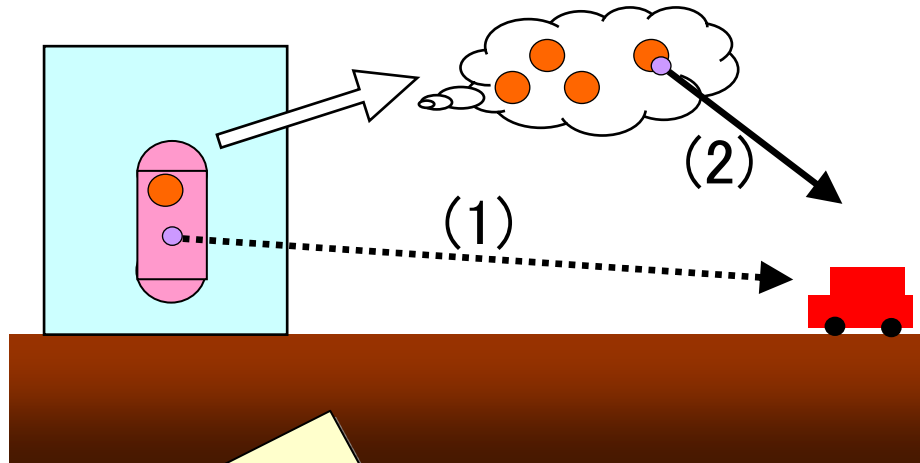
9. Origin of measured neutrons

The neutrons observed near the main gate were released in the course of fuel melting at Units 2 and 3, and may have been generated by the spontaneous nuclear fission of actinides.

Neutrons on route (1) inside the reactor were measured directly.

Delayed neutrons on route (2)-1 deriving from the collapse of discharged fission products (Br-87, etc.) were measured.

On route (2)-2, we measured neutrons deriving from the spontaneous nuclear fission of discharged actinides (Cm-242, etc.).

O - The timing coincided with that of fuel melting.
- Possible given the detection of actinides in sampled soil thought to come from the Fukushima Daiichi NPS accident.
