Physics of Reactors Topical Meeting 2014 - PHYSOR2014

Current Status on Fukushima Daiichi NPS

September 29, 2014

Tokyo Electric Power Company

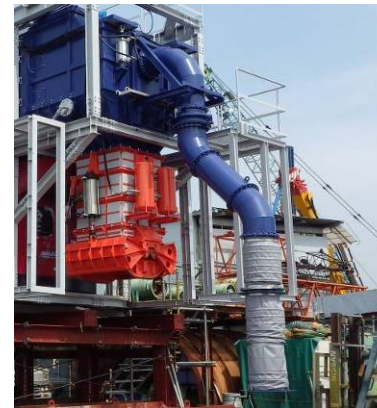
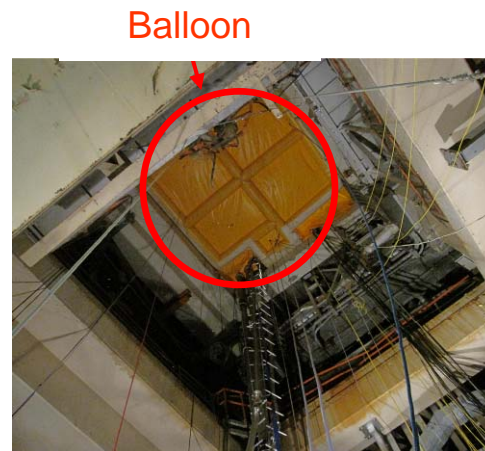
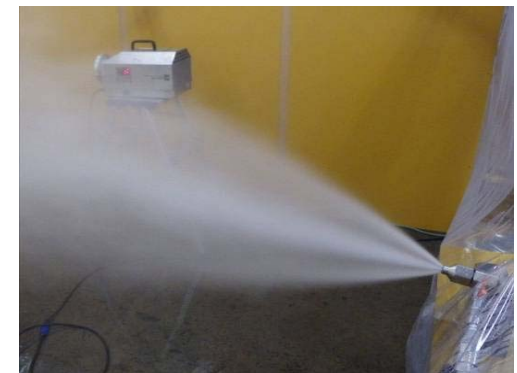
- To repair (seal the water leak locations of) the PCV in preparation for the fuel debris removal, investigation under vent pipes was conducted to identify the leak locations in the PCV.
- With the images taken by the camera equipped with the water boat, it was checked whether there is any water flow from the sleeve ends of vent pipes or not, and the status of the sand cushion drain pipes was also checked (by viewing appearance).

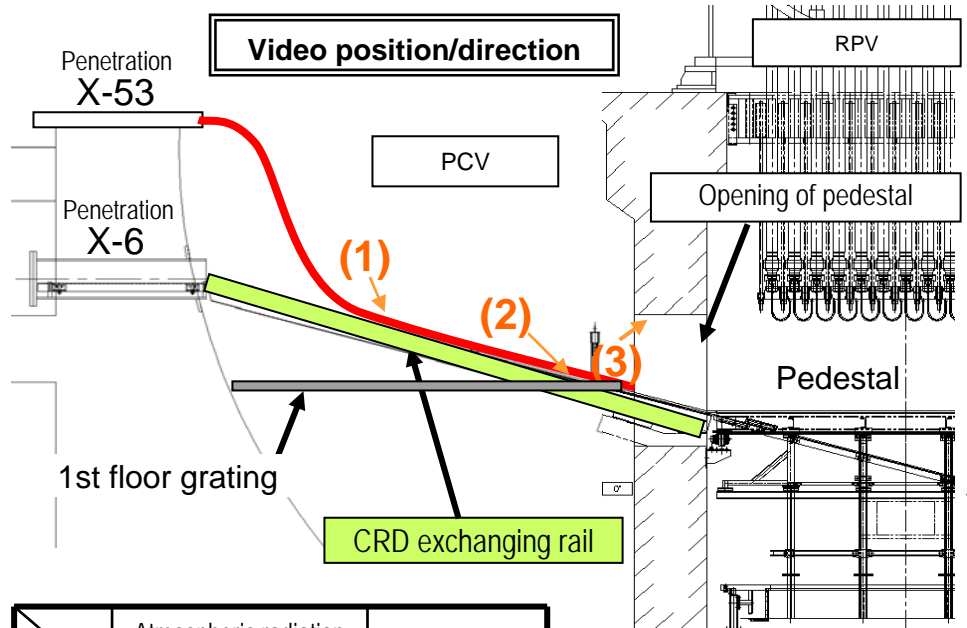
- A survey will be conducted on the pedestal's internal side in order to check the condition inside the PCV (fuel debris position, etc.).
- In preparation for the survey, equipment was introduced from the penetration (cameras, dosimeters and thermometers) to investigate the status of the CRD exchanging rail, etc. (August 12, 2013)
- The survey was conducted up to the vicinity of the opening of pedestal. However, the interior could not be checked due to interference by deposits, etc.
- Based on the issues identified by the preliminary survey, survey equipment has been developed and will be tested in the field in the second half of FY 2014.

Atmospheric radiation levels	Temperature
(1)	About 24 Sv/h	About 41 °C
(2)	About 30 Sv/h	About 45 °C
(3)	About 36 Sv/h	About 45 °C

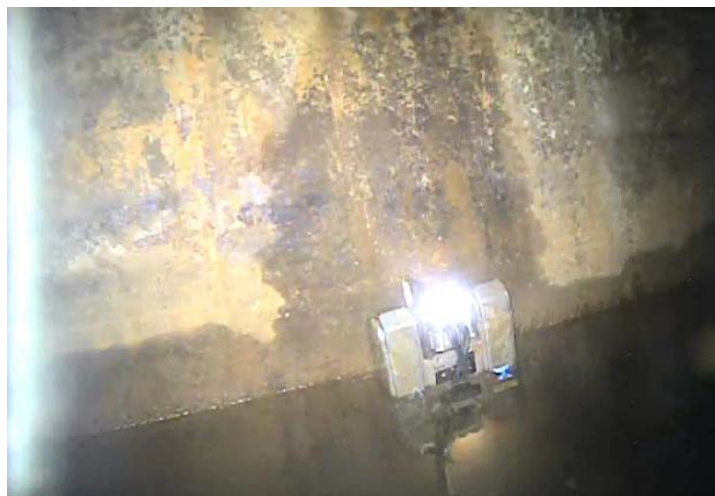
During the water level measuring

- The measuring was conducted from January 14 to 16 at multiple lines (multiple longitudes) in order to enhance the reliability of specifying the exact water level. The numerical values of January 14 and 15 in the following chart were obtained in the middle of the series of the data collecting work.

Measuring date	January 14	January 15	January 16
Water level inside S/C	Approx. OP. 3,210 mm	Approx. OP. 3,160 mm	Approx. OP. 3,150 mm
Water level inside Torus Room (Reference)	Approx. OP. 3,230 mm	Approx. OP. 3,190 mm	Approx. OP. 3,160 mm
Water level difference	Approx. 20 mm	Approx. 30 mm	Approx. 10 mm
Measuring method	Direct distance measuring for structures the in the water

[Note] It is estimated that the water level inside the S/C is influenced by the change of the water level of accumulating water inside the torus room.

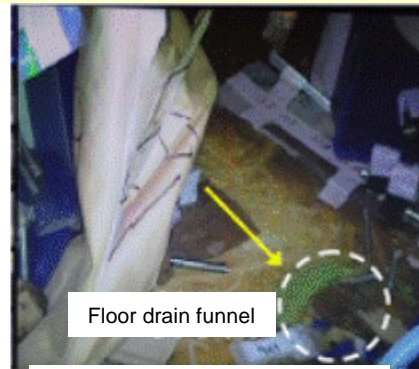
- On January 18, 2014, checking the camera images from the debris removal robot (ASTACO-SoRa) in unit 3, our personnel found that water flowing from the area near the door of the main steam isolation valve (MSIV) room toward the floor drain funnel in the vicinity in the north-eastern area on the 1st floor at Unit 3 R/B.
- On January 21, 2014, it was identified that water injection amount was greatly reduced while the robot was operated for debris removal work.
- No change on plant parameter, etc has been found.

Water flow confirmed (on Jan. 18)

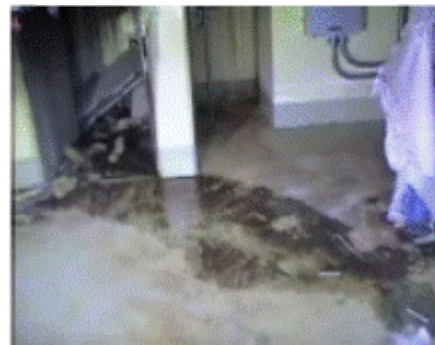
Water flow reduction confirmed (on Jan. 21)

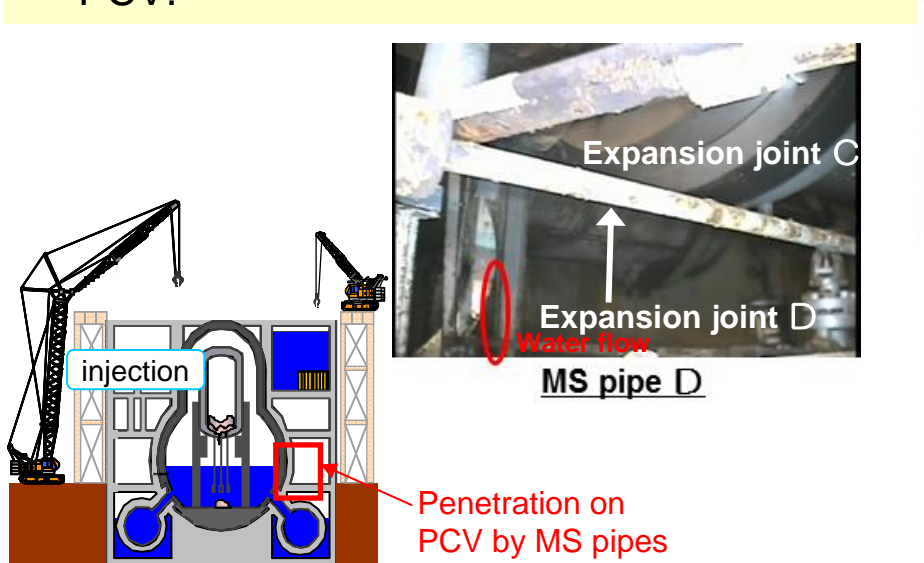
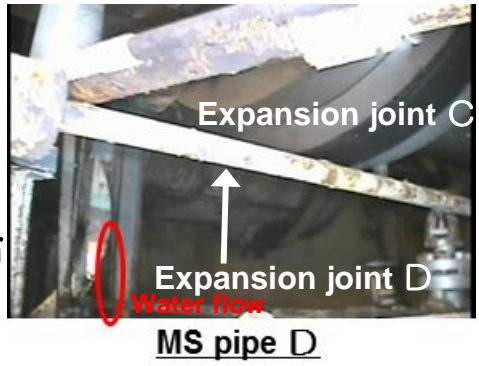
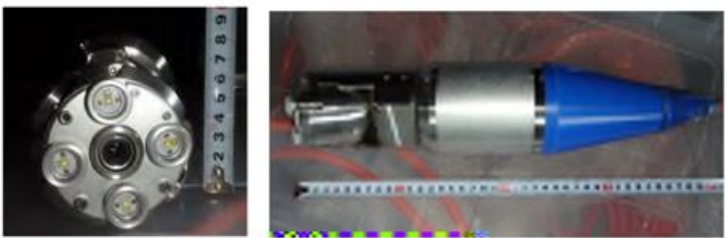
- On May 15, by inserting a camera into the Main Steam Isolation Valve (MSIV) room, a leak from around a Main Steam (MS) line was identified. It was the first confirmation of a leak from the Unit 3 PCV.

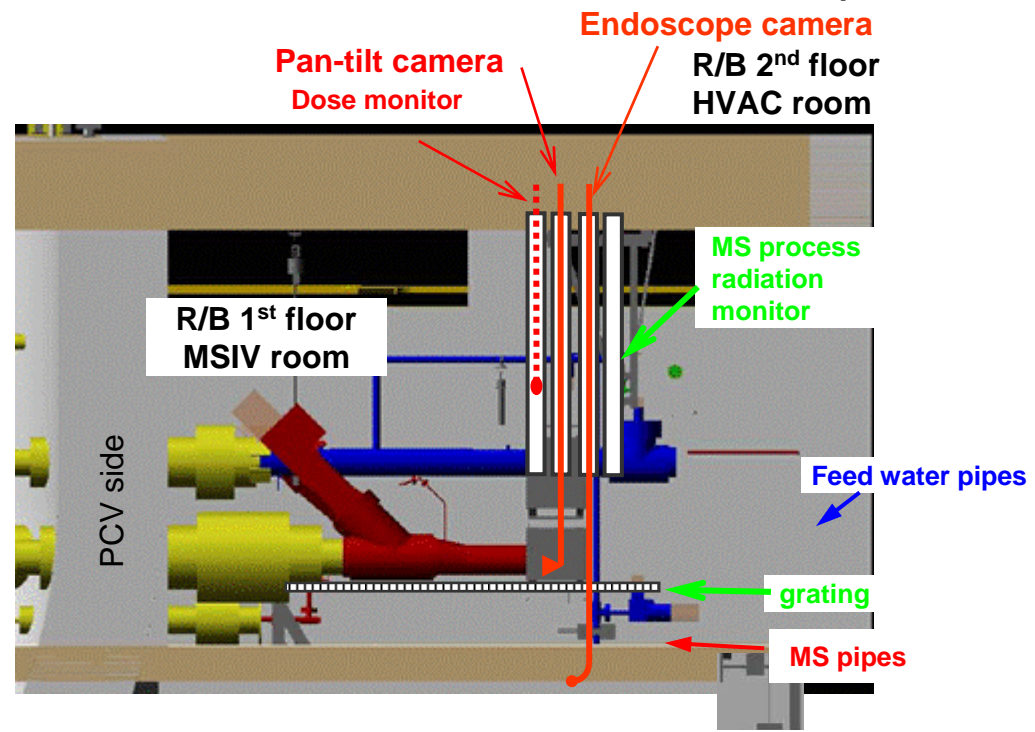
Cross section of MSIV room

- There are a total of 9 pipe penetration seals in the MSIV room: main steam system (X-7A~D), main steam system drain (X-8), feed water system (X-9A,B), and the backup penetrations (X-46,47)
- The height of the main steam system and the main steam system drain penetrations (total of 5 places) are estimated to be at a lower level than PCV water level (estimated water level from pressure conversion)
